FLIGHTfax

Army Aviation Composite Risk Management Information

Rescue "Turned Bad"

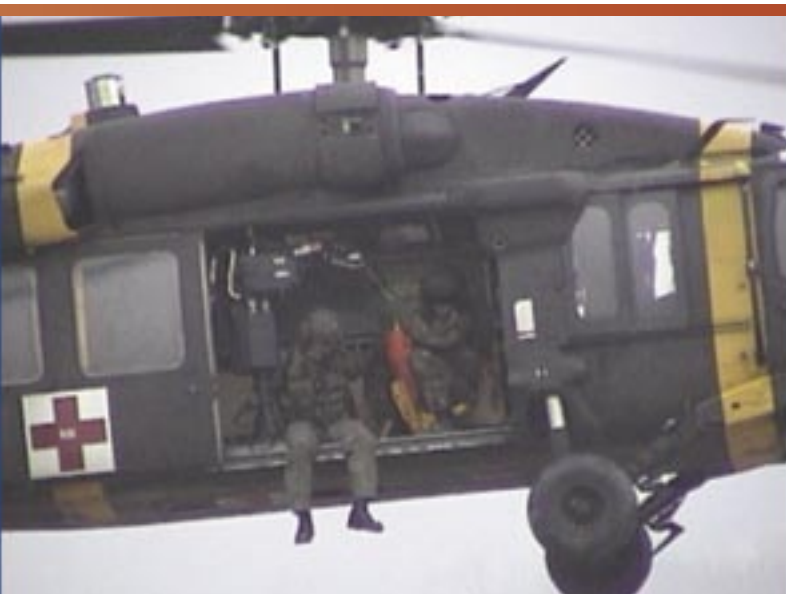
Despite the best efforts of the crew chief, the hoist cable swing could not be arrested, and the cable rubbed against the side of the aircraft during load oscillations.

The post-accident investigation of the hoist cable revealed several cable strands were broken at different points along the cable. This compromise of the cable integrity occurred when it contacted the side of the aircraft. During the oscillations, the hoist cable rubbed against the cargo door track, creating a sharp and serrated edge. As the cable continued to contact the sharpened door track, the cable's outer sheath was cut, weakening the cable to the point that it could no longer support the load.

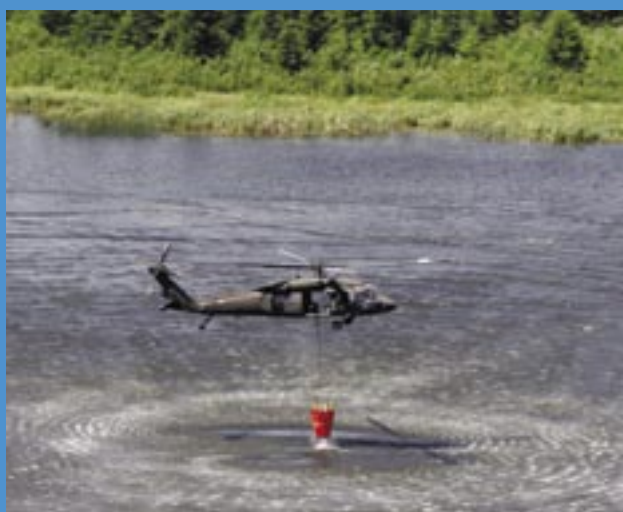
Whether it involves a medical Skedco litter hoist (figure 1) or rescue down-the-wire hoist operation, the hoist *must* operate efficiently and safely. Composite Risk Management can be applied to reduce hoist failures. Some CRM considerations in hoist operations include training, equipment inspection and the area of operation.
